## THE EFFECT OF JOINT SEALING ON THE PERFORMANCE OF THIN WHITETOPPING SECTIONS AT MNROAD

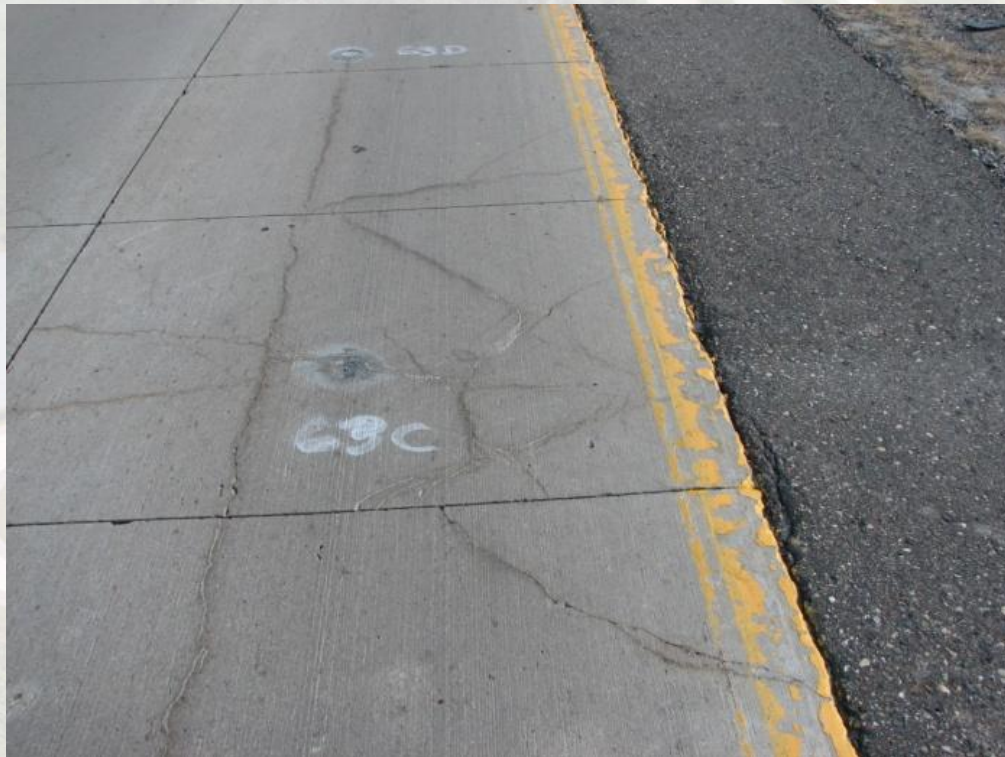
**Figure 3. Cracked and “shattered” panels in Cell 63 (Fall 2010).**

Throughout their lives, the test cells were monitored closely for distress and serviceability. By fall 2010, the 5 inch thick cells 60 and 61 had 11% and 8% of their panels cracked, respectively. Interestingly though, for the 4 inch thick cells, cell 63 with unsealed joints had 55% of its panels cracked, compared to 11% for cell 62 with the sealed joints. Not only was there more cracked panels in cell 63, but degree and type of cracking was different. Figure 3 shows a typical “shattered” panel from cell 63, while Figure 4 shows the increasing rate at which the panels were deteriorating. In an effort to keep the test section in service, the joints and edges of panels in cell 63 were sealed with methyl-methacrylate and hot-pour sealant in Fall 2010. Sealing of the joints and edges did seem to slow the rate of crack development in the panels, allowing the section to remain in service until full panel replacement repairs could be done during the summer of 2011.

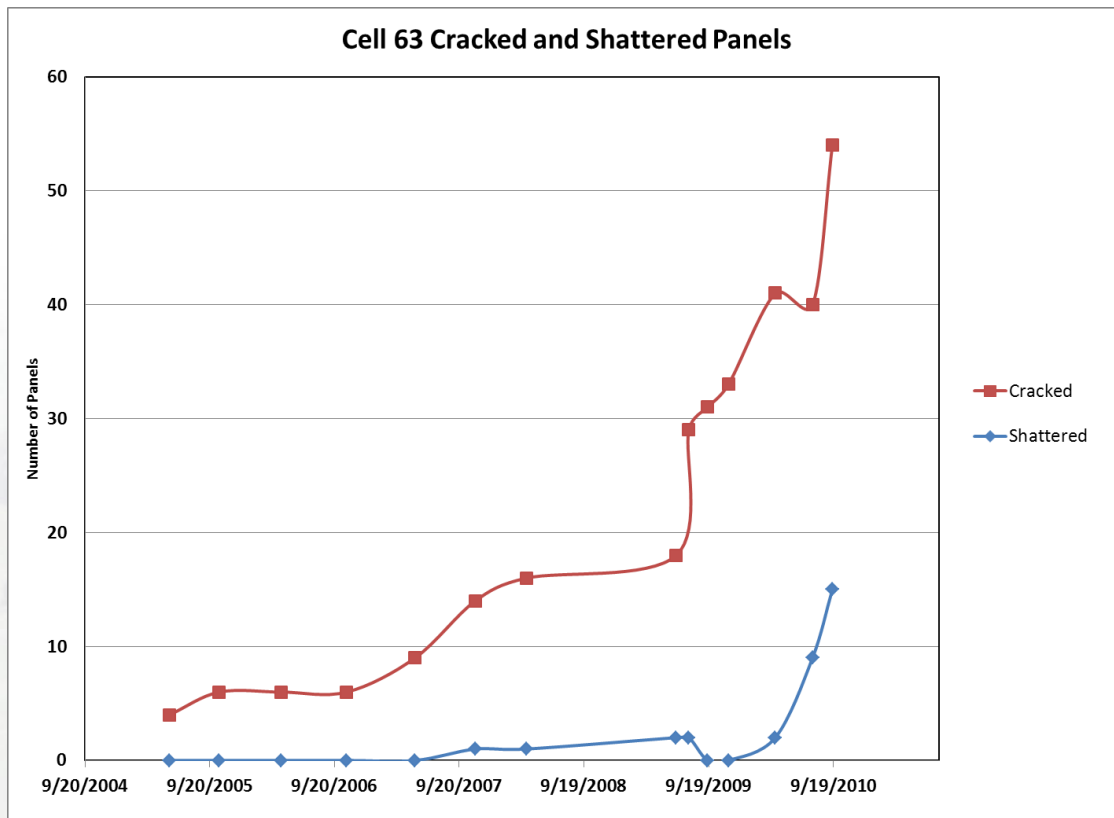
**Figure 4. Development of cracking distress in Cell 63.**
